## CO<sub>2</sub> Absorber

**Company Name:** Withheld

**Location:** Deer Park, TX USA

**Coating:** Mascoat Industrial-DTI

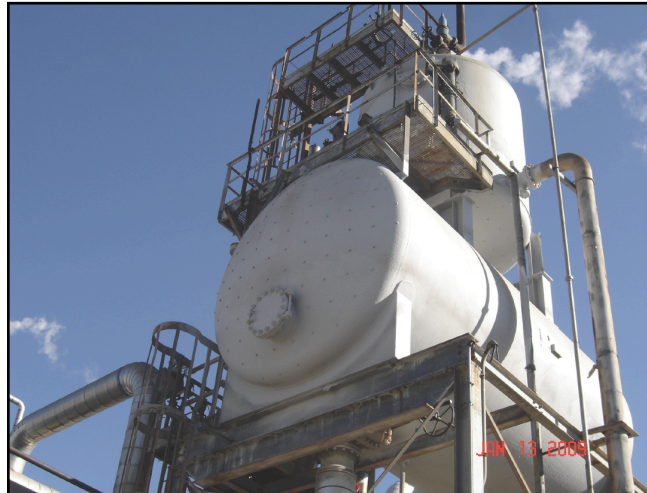
When a CO<sub>2</sub> Absorber in Deer Park, TX had surface temperatures above personnel protection limits, the company called on Mascoat to help solve their problem

Due to the humid environment in Deer Park, which is just south of Houston, the company felt that they could not use conventional insulation. The high humidity in the environment would inevitably lead to Corrosion Under Insulation, a major problem at most refineries and storage facilities around the world. Also, the tower was constantly exposed to water vapor and chemical exposure. From their past experience with Mascoat Industrial-DTI, the company knew that the coating would be able to sufficiently protect personnel while preventing CUI from ever starting.

The absorber was first sandblasted and then primed with an epoxy primer. It had to be primed since the substrate was carbon steel, which can flash-rust due to the coatings water-based formula. Brand Energy Solutions, an Certified Mascoat Applicator, then proceeded to apply 60 mils in 20 mil coats to the unit. After the coating had fully cured, the client measured the surface temperature and saw that it had gone from 160°F to 130°F, within personnel protection limits.
